**Project: Landfill Monitoring**  
**Client: Yeager Skanska**  
**Location: Milliken Landfill, Ontario, California**  
**Year: 2005**

### Application Notes:

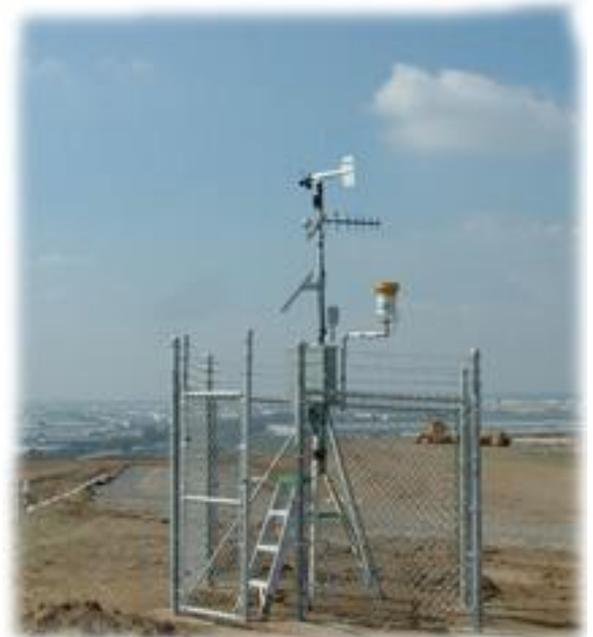
*Weather Station installed at the top of the newly capped area of the Milliken Landfill*

Yeager Skanska had chosen several sites and had a 10 ft. x 10 ft. chain link fence installed around the area they wanted to put the weather stations. We installed one station on the top of the capped area and a second station about halfway down the northern side of the capped area. The weather station included an WS5103 RM Young Wind Speed and Direction Sensor, an RH45 Visalia Relative Humidity and Air Temperature Sensor, a Kipp & Zonen CM3 Pyranometer, a Texas Electronics RG5258 8" Tipping Bucket Rain Gauge, and five Campbell Scientific CS615 Soil Moisture Probes installed at 6", 12", 18", 30" and 42" depths.

The system is powered with a PS12LA Rechargeable Power Supply that is recharged using an MSX10 10-Watt Solar Panel. A Campbell Scientific CR23X Data logger is used to measure and record the data on an hourly basis. The system has an Air Link Redwing Cellular Modem attached to it.

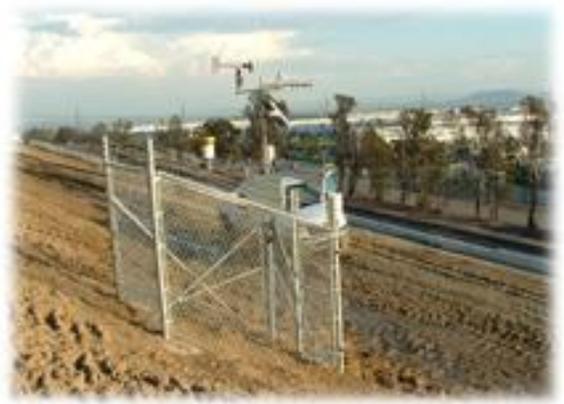
*Weather Station installed about half way down the north side of the capped area of the Milliken Landfill*
